# Field Evaluation of Reinforced Concrete Repairs Using Hydrodemolition, Galvanic Cathodic Protection, or Impressed Current Cathodic Protection

**Final Report VTRC 25-R22**

June 2025

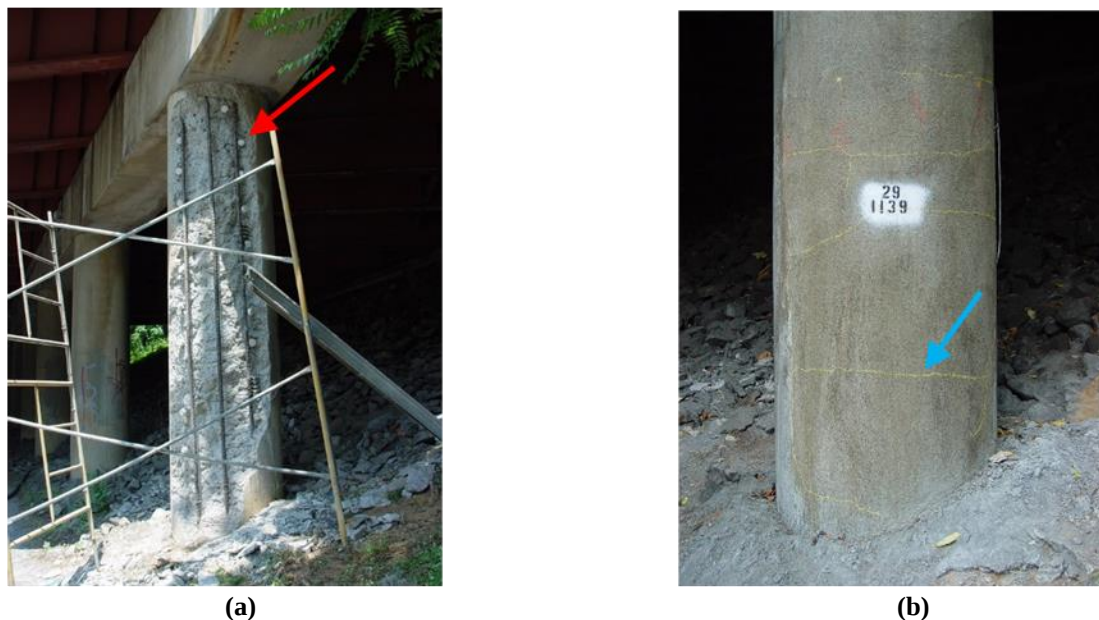
**Figure 1. Placement of Anodes in Shotcrete Repair Area: (a) Column with DPG anodes (red arrow) tied to steel prior to shotcrete repair and (b) after shotcrete hardens and exhibits shrinkage cracks (blue arrow) that were emphasized on the column using yellow crayon. The cracks widths marked in yellow are less than 0.01 inch (Brown and Sharp, 2005).**

proper placement, which makes it a specialized and costly repair system. Moreover, field experience of shotcrete repairs indicates variable performance for this type of repair, such as the cracks in the finished repair product (Figure 1b). Finally, in both VDOT A3 concrete and shotcrete repair systems, bonding of the repair material to the existing concrete is another concern and requires proper surface preparation of the existing concrete through removal of deteriorated concrete—a roughened surface that is saturated surface dry during the placement.

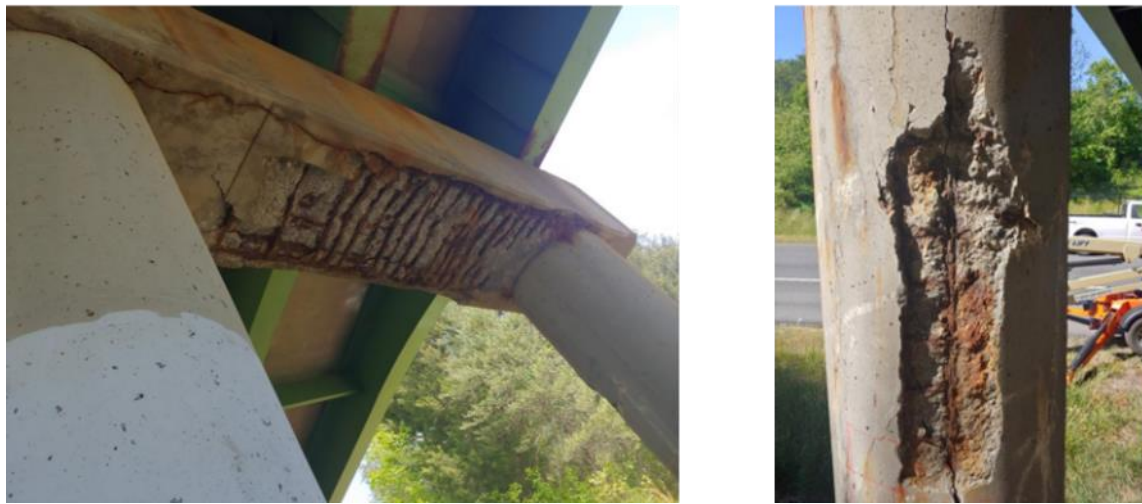
The visual survey of the Route 605 Bridge was conducted on Piers 1 and 3 prior to demolition and remediation work. Corrosion of the reinforcing steel was present in the caps and columns on Piers 1 and 3. Corrosion of the reinforcement resulted in staining, concrete spalling, and steel section loss, with typical examples shown in Figures 3 and 4.

**Figure 3. Corrosion on Pier 1 of the Route 605 Bridge**

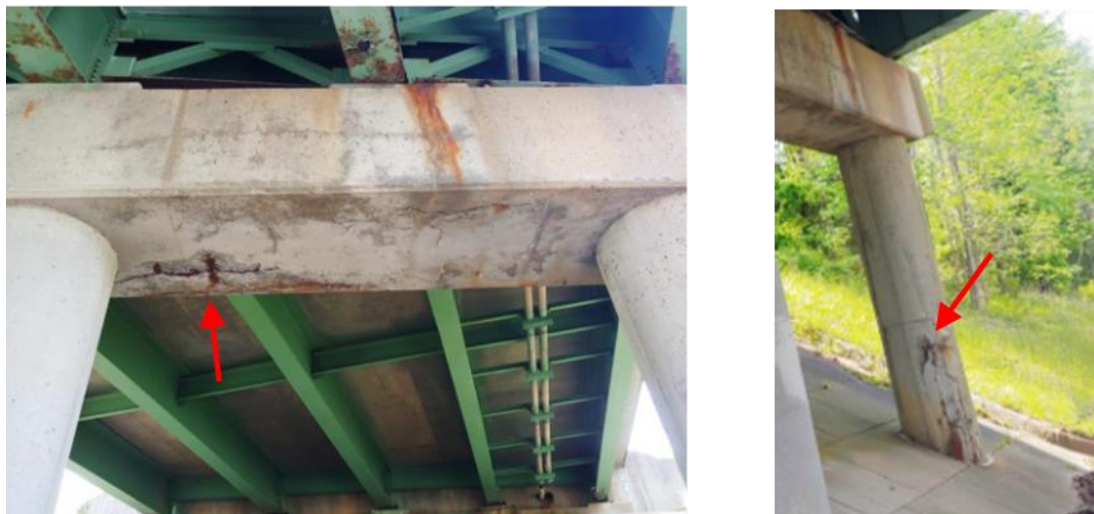
**Figure 4. Corrosion on Pier 3 of the Route 605 Bridge, as Indicated by the Red Arrows**

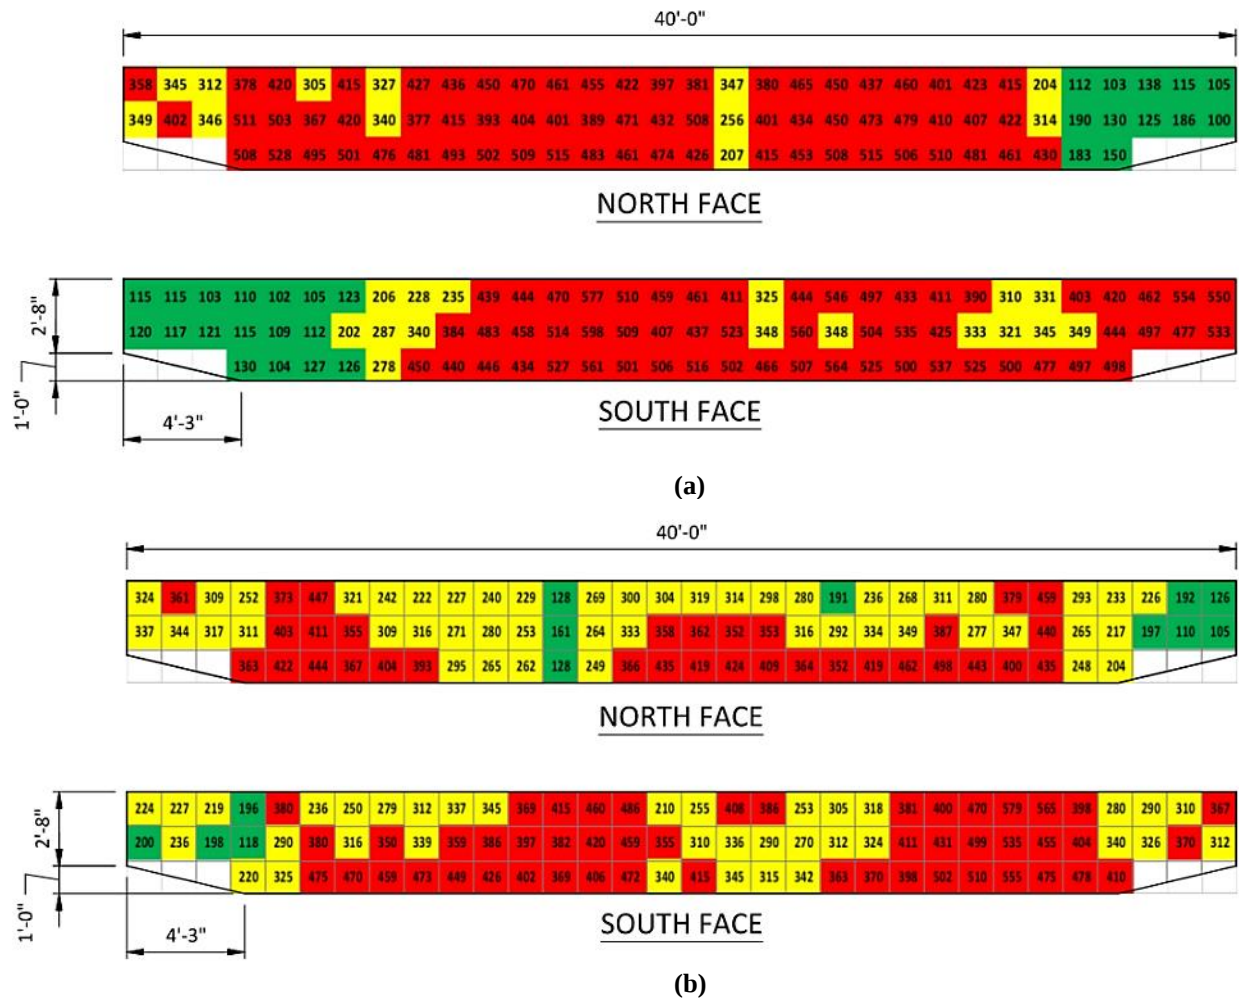
**Figure 5. Half-Cell Measurements Using a 16-x-16-Inch Grid Pattern Show a High Probability of Corrosion on the (a) Pier 1 and (b) Pier 3 Caps of the Route 605 Bridge. Numbers in each square are the magnitude of the half-cell measurement but are reported as positive values instead of the measured negative value (VDOT Contracted I-64 Bridge Substructure Studies Project, Route 605, 2021).**

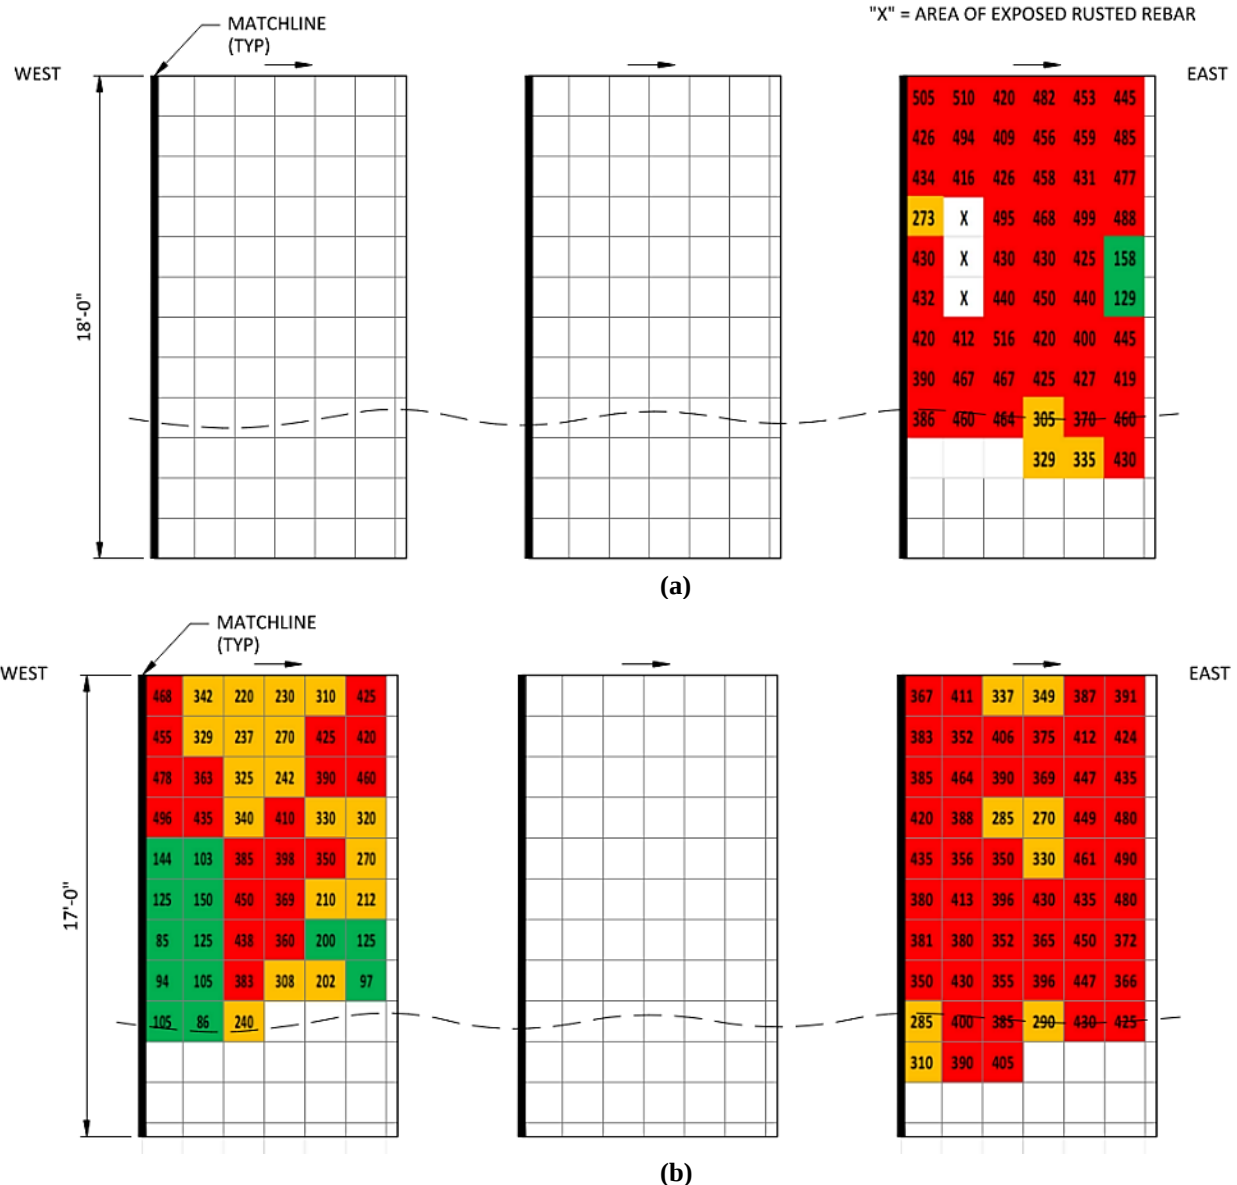
**Figure 6. Half-Cell Measurements Using a 16-x-16-Inch Grid Pattern Show a High Probability of Corrosion on the (a) Pier 1 and (b) Pier 3 Columns of the Route 605 Bridge. Numbers in each square are the magnitude of the half-cell measurement but are reported as positive values instead of the measured negative value. Dashed line indicates approximate ground-level location (VDOT Contracted I-64 Bridge Substructure Studies Project, Route 605, 2021).**

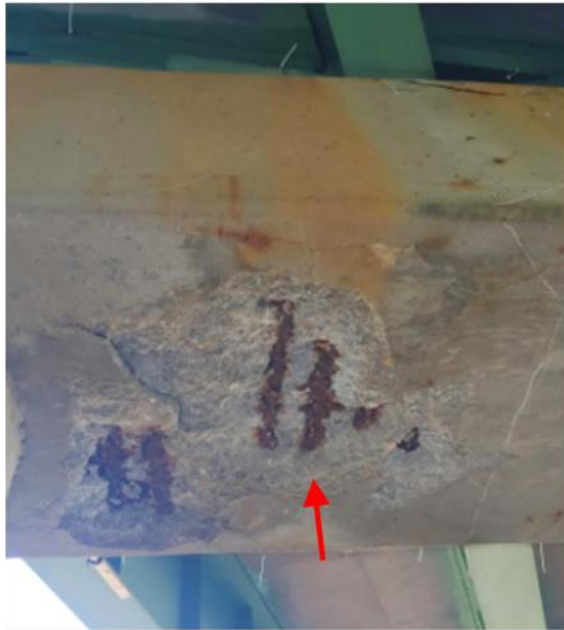
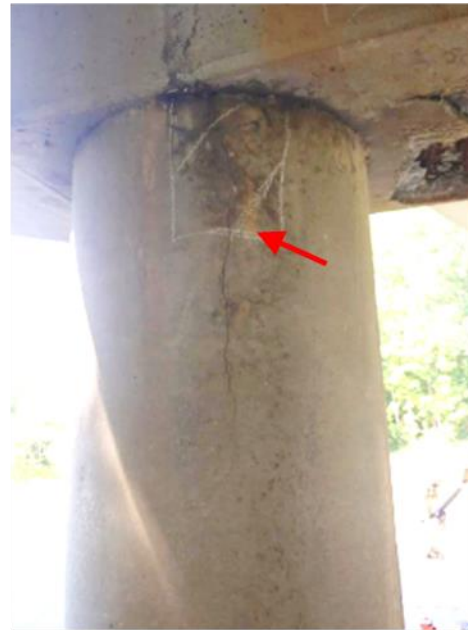
The visual survey of the Route 629 Bridge was conducted on Piers 1 and 3 prior to demolition and remediation work. Corrosion of the reinforcing steel was present in the Pier 1 and Pier 3 caps and columns. Corrosion of the reinforcement resulted in staining, concrete spalling, and steel section loss, with typical examples shown in Figures 7 and 8.

**Figure 7. (a) Arrow Pointing to the Corroded Reinforcement on Pier 1 of the Route 629 Bridge; (b) Arrow Pointing to the Cracked and Delaminated Area**

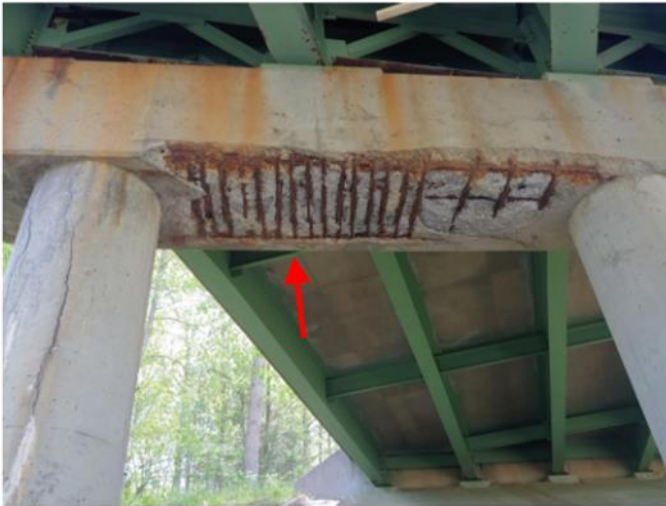
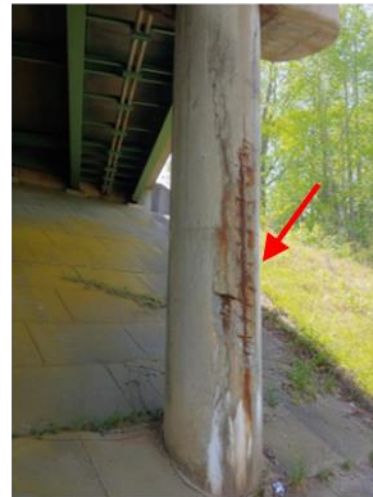
**Figure 8. Corrosion on Pier 3 of the Route 629 Bridge, as Indicated by the Red Arrows**

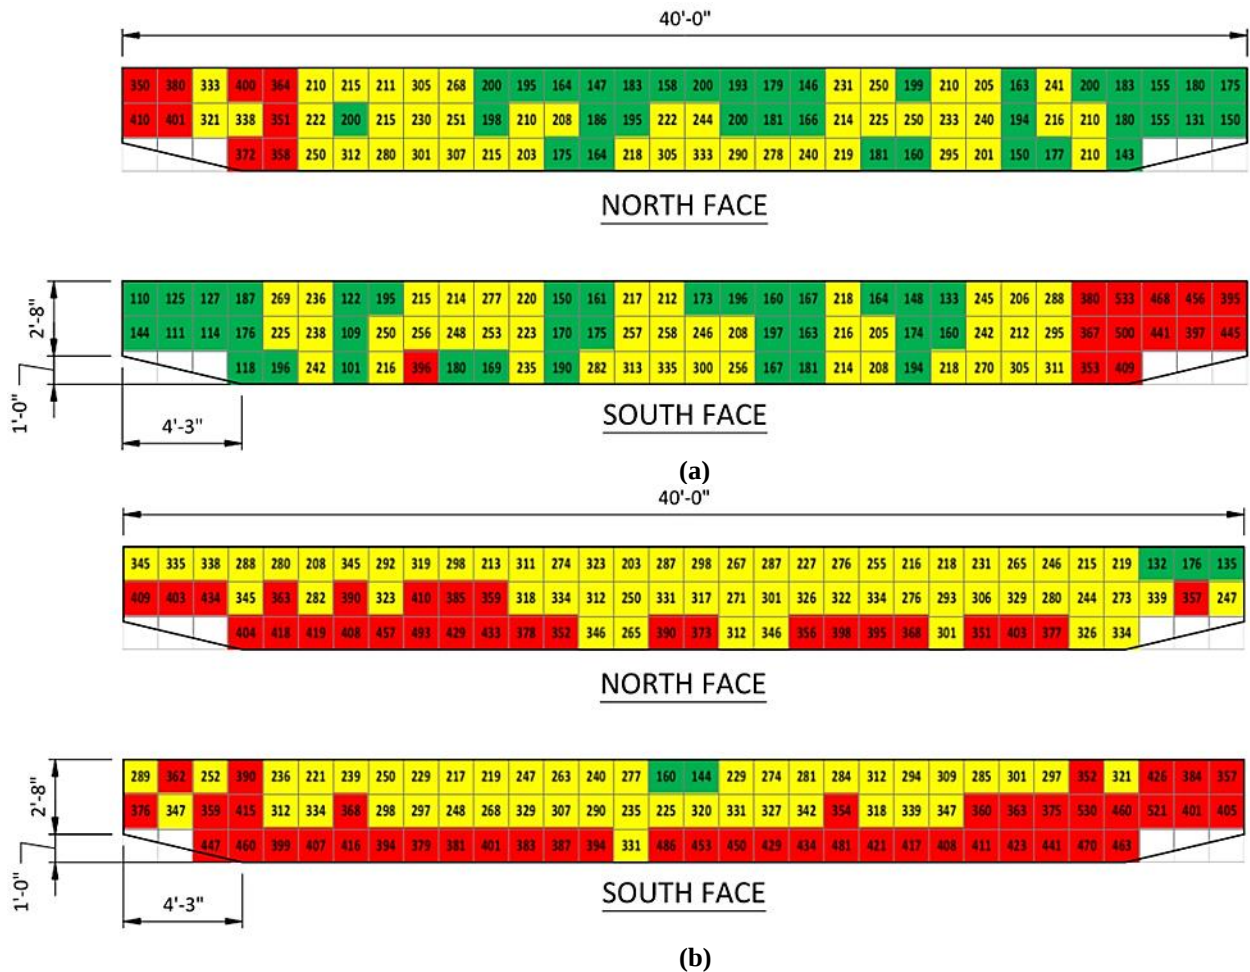
Figure 9. Half-Cell Measurements Using a 16-x-16-Inch Grid Pattern Show the Probability of Corrosion on the (a) Pier 1 and (b) Pier 3 Caps of the Route 629 Bridge. Numbers in each square are the magnitude of the half-cell measurement but are reported as positive values instead of the measured negative value (VDOT Contracted I-64 Bridge Substructure Studies Project, Route 629, 2021).

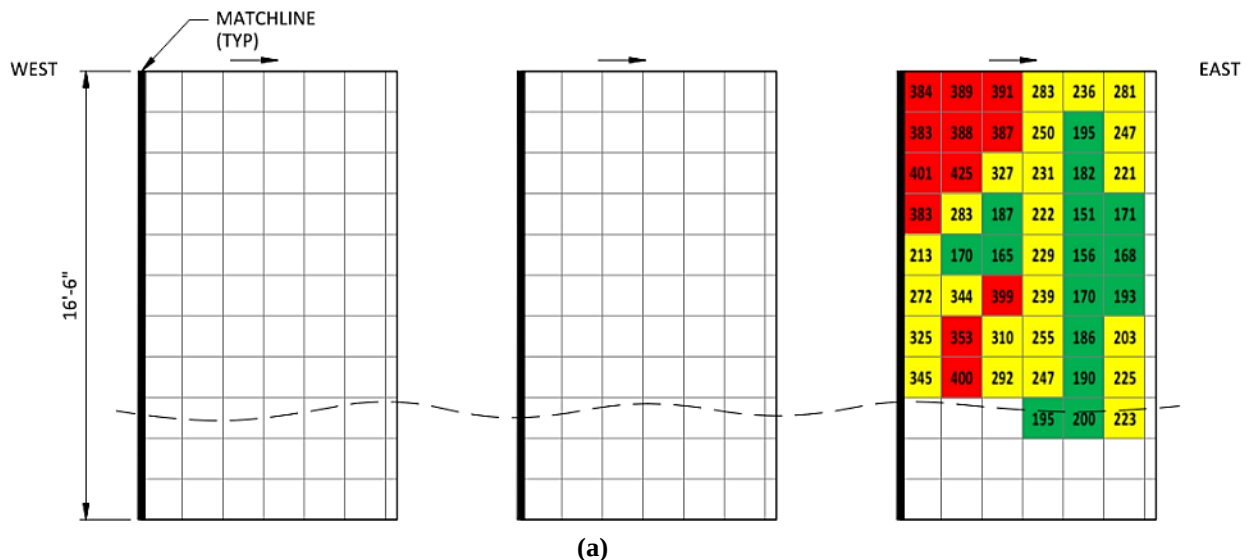
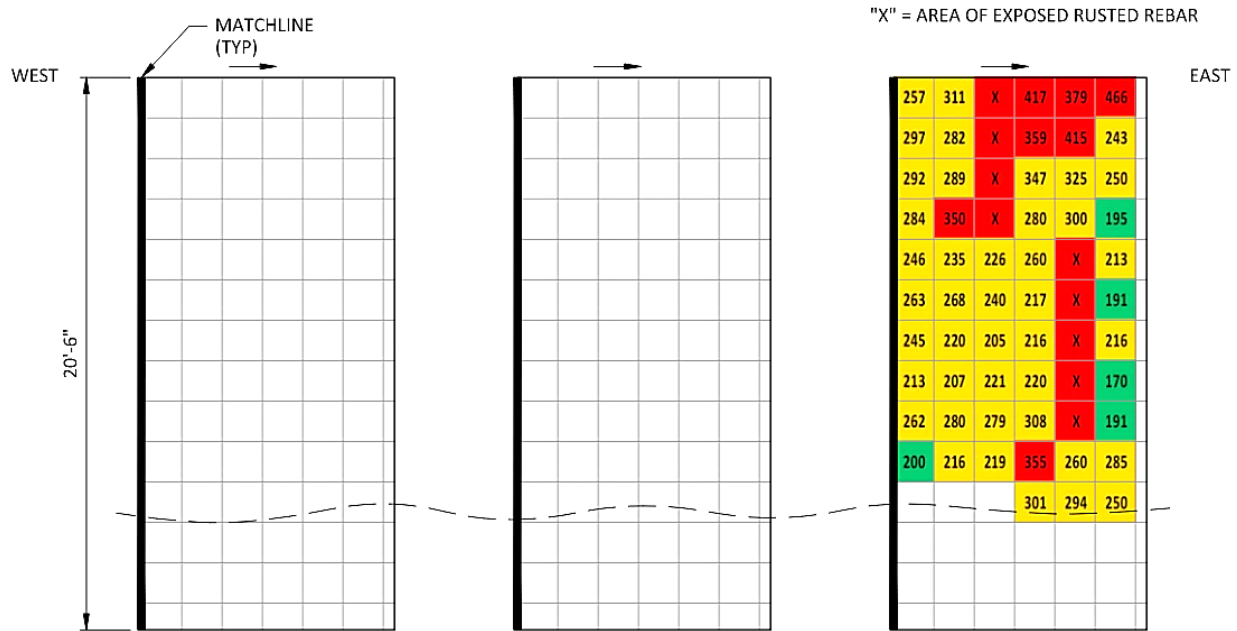
Figure 10. Half-Cell Measurements Using a 16-x-16-Inch Grid Pattern Show the Probability of Corrosion on the (a) Pier 1 and (b) Pier 3 Columns of the Route 629 Bridge. Numbers in each square are the magnitude of the half-cell measurement but are reported as positive values instead of the measured negative value. Dashed line indicates approximate ground level location (VDOT Contracted I-64 Bridge Substructure Studies Project, Route 629, 2021).

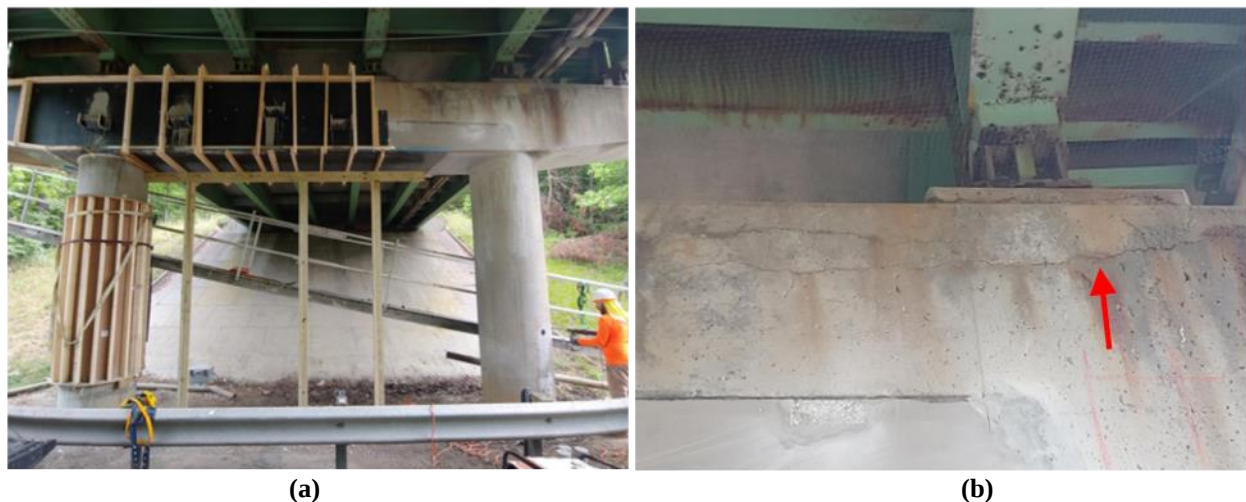
Figure 11. (a) Remediation of Pier 1 of the Route 522 Bridge; (b) Magnified View with Red Arrow Showing the Crack in an Unrepaired Area

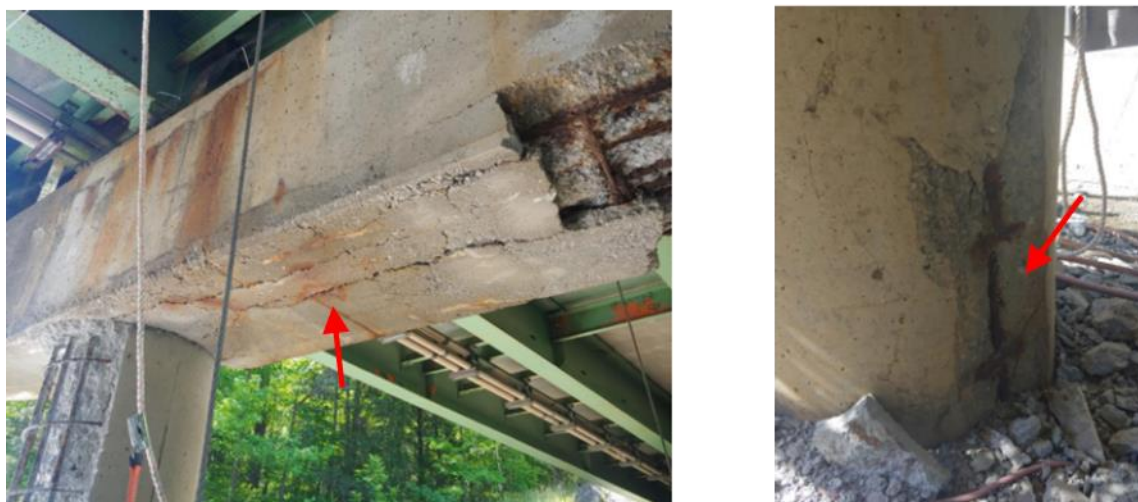
**Figure 12. Corrosion Related Damage on Pier 4 of the Route 522 Bridge, as Indicated by the Red Arrows. The picture on the left shows where concrete was removed for the contractor to make repairs.**

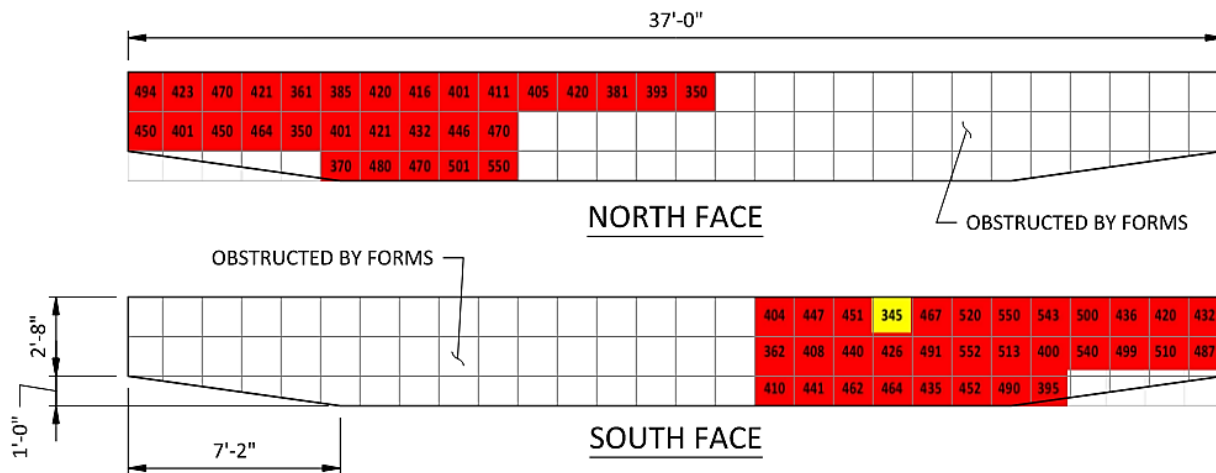
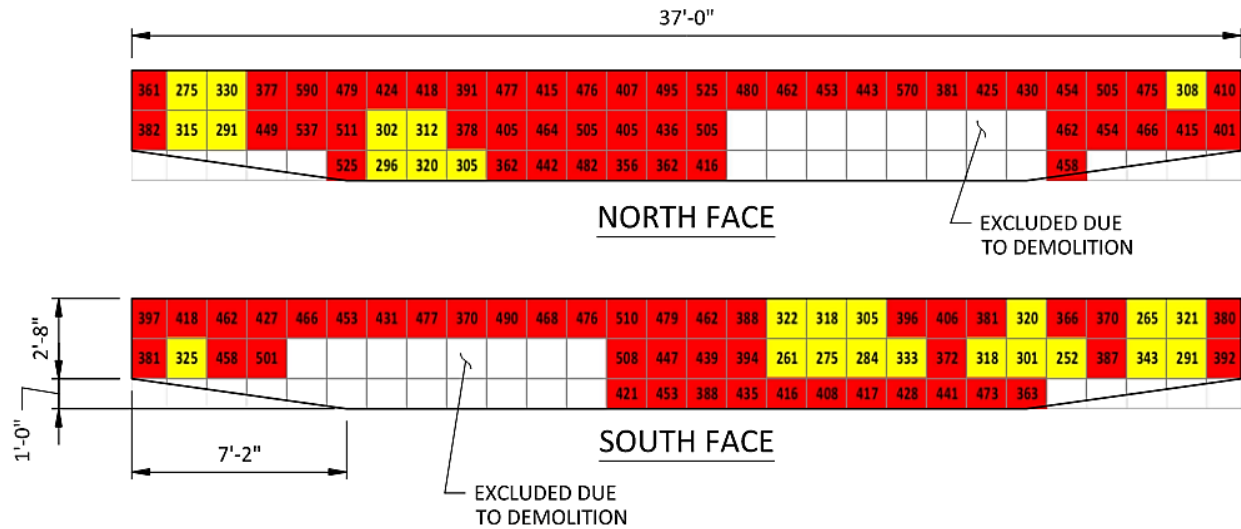
Figure 13. Half-Cell Measurements Using a 16-x-16-Inch Grid Pattern Show a Probability of Corrosion on the (a) Pier 1 and (b) Pier 4 Caps of the Route 522 Bridge. Numbers in each square are the magnitude of the half-cell measurement but are reported as positive values instead of the measured negative value (VDOT Contracted I-64 Bridge Substructure Studies Project, Route 522, 2021).

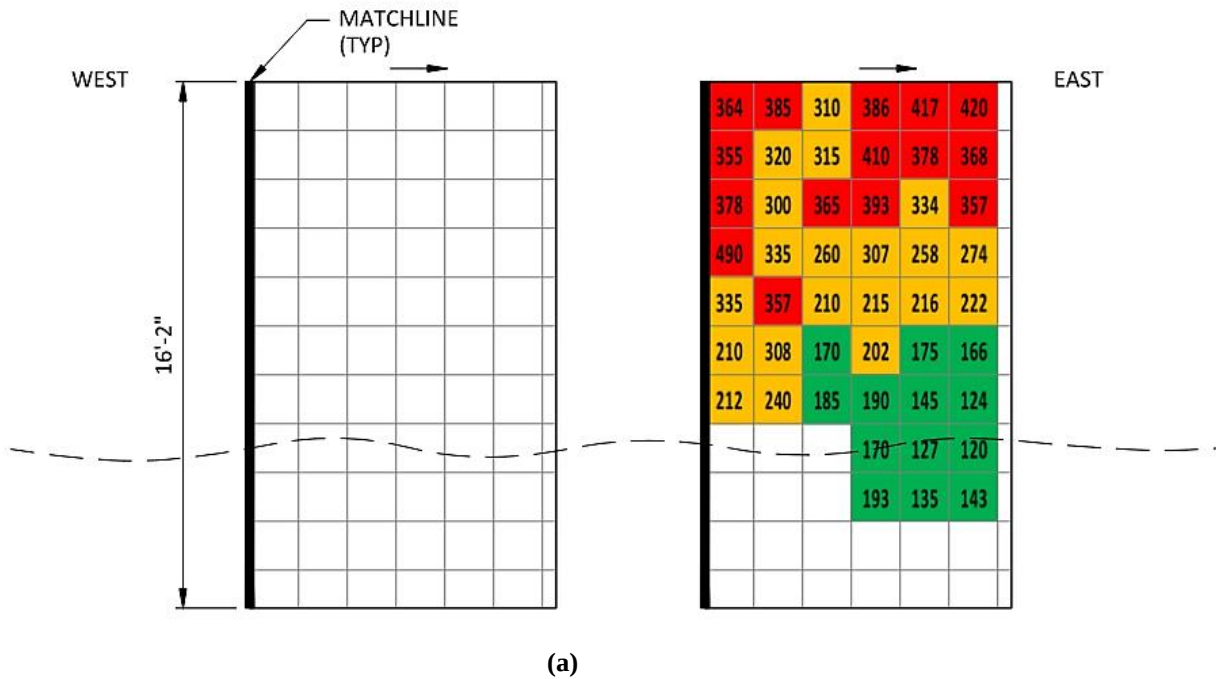
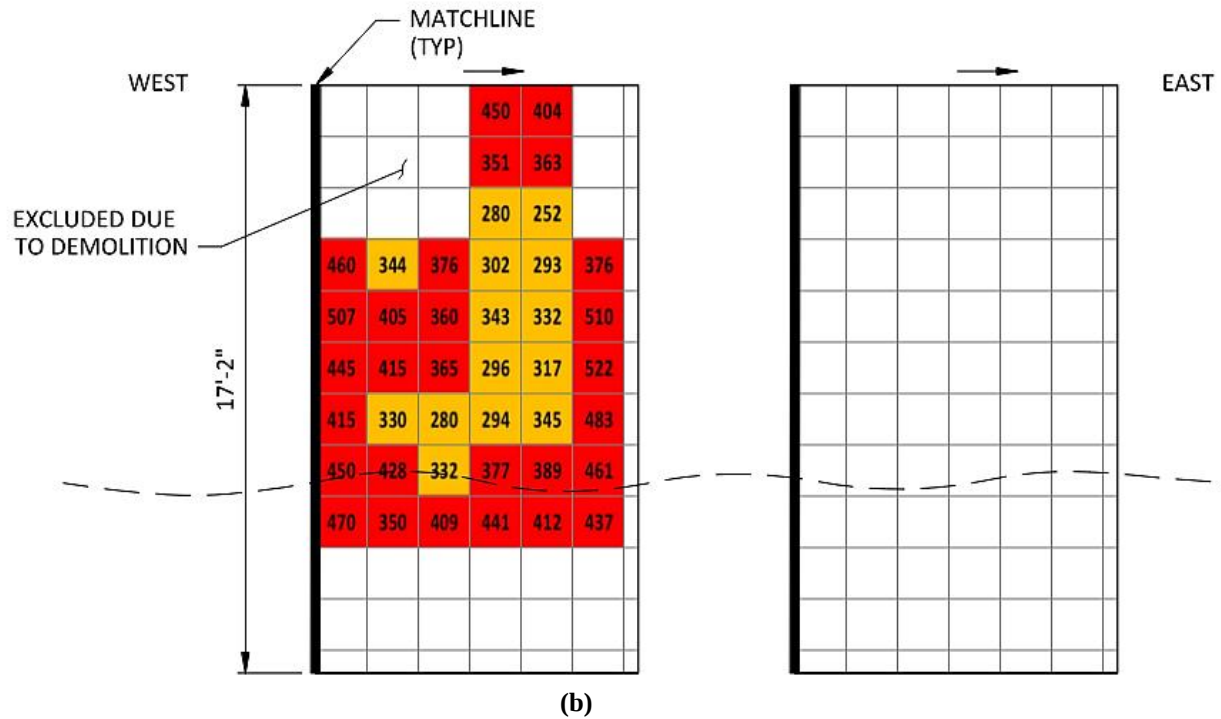
Figure 14. Half-Cell Measurements Using a 16-x-16-Inch Grid Pattern Show a Probability of Corrosion on the (a) Pier 1 and (b) Pier 4 Columns of the Route 522 Bridge. Numbers in each square are the magnitude of the half-cell measurement but are reported as positive values instead of the measured negative value. The dashed line indicates approximate ground level location (VDOT Contracted I-64 Bridge Substructure Studies Project, Route 522, 2021).

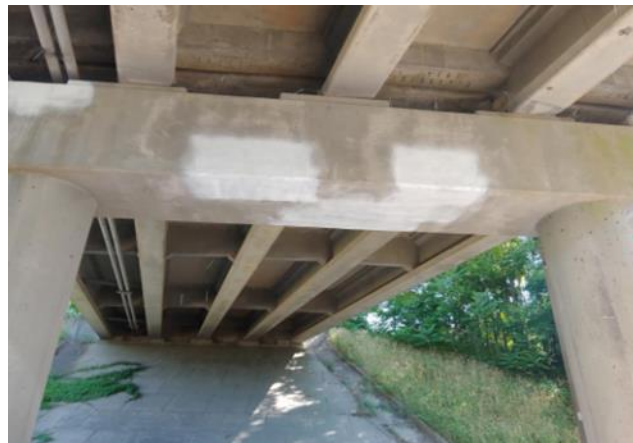
Figure 15. Condition after Remediation of Pier 1 of the Route 621 Bridge before Applying Epoxy Coating

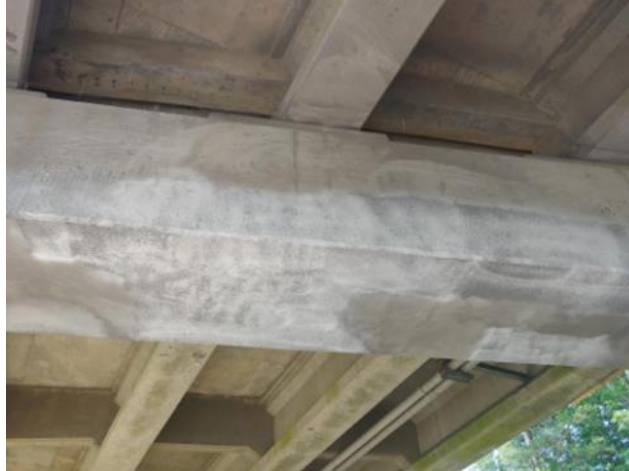
**Figure 16. Condition after Remediation of Pier 4 of the Route 621 Bridge before Applying Epoxy Coating**

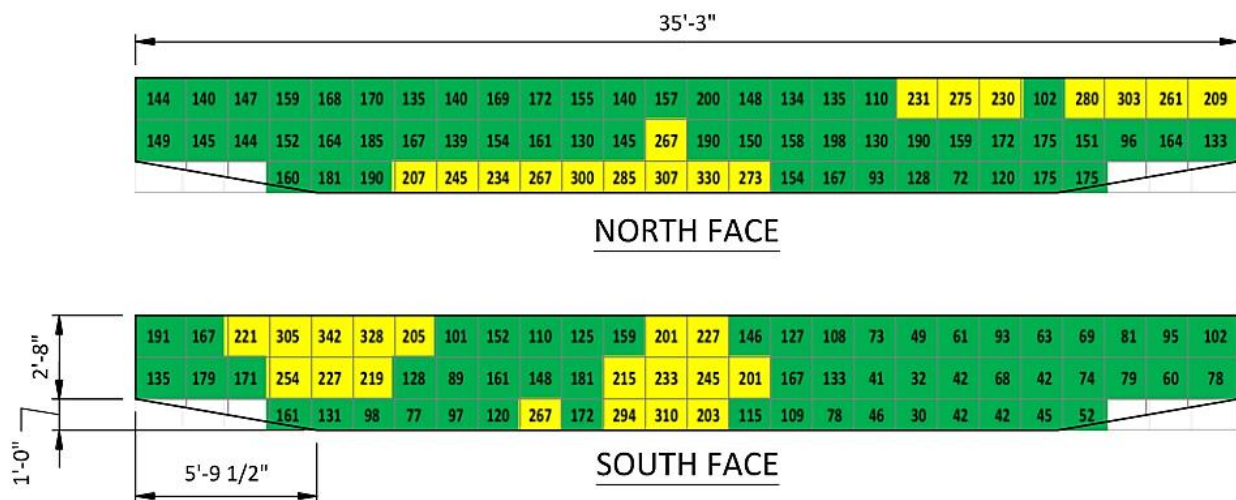
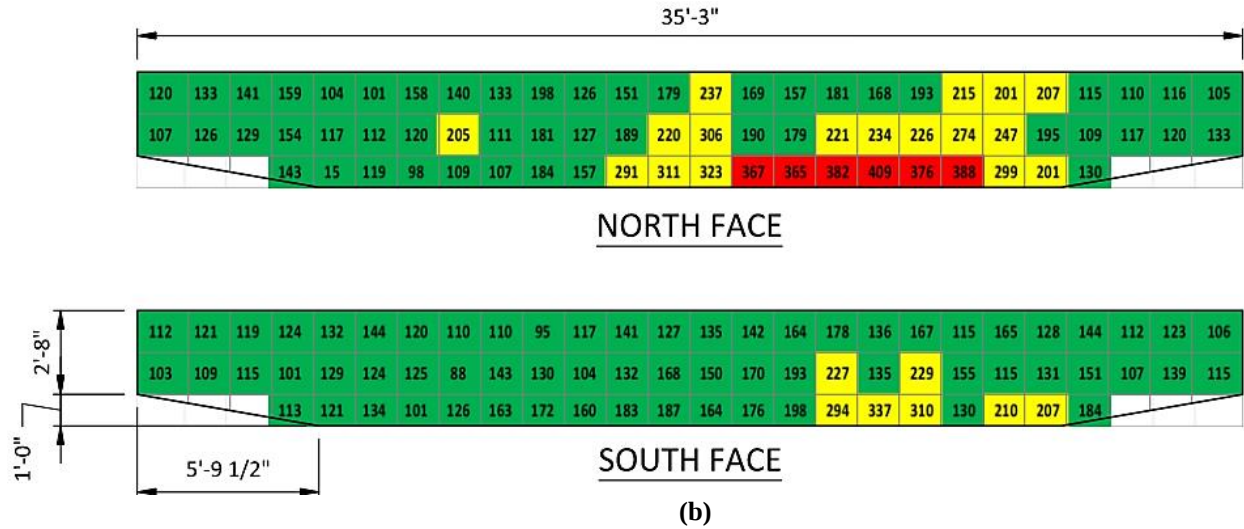
Figure 17. Half-Cell Measurements Using a 16-x-16-Inch Grid Pattern Show a Probability of Corrosion on the (a) Pier 1 and (b) Pier 4 Caps of the Route 621 Bridge. Numbers in each square are the magnitude of the half-cell measurement but are reported as positive values instead of the measured negative value (VDOT Contracted I-64 Bridge Substructure Studies Project, Route 621, 2021).

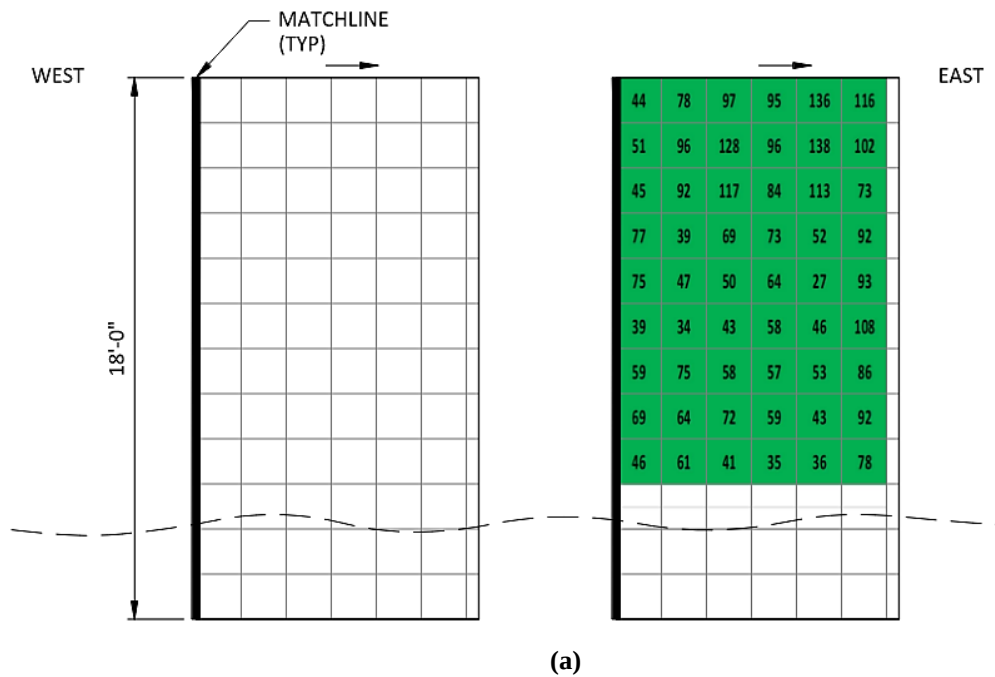
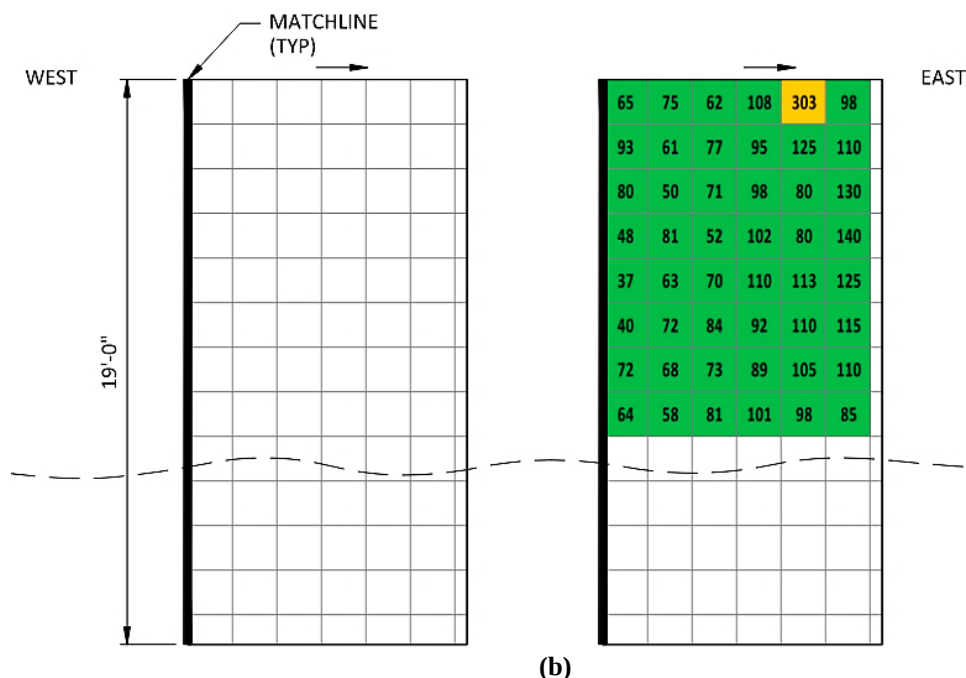
**Figure 18. Half-Cell Measurements Using a 16-x-16-Inch Grid Pattern Show a Probability of Corrosion on the (a) Pier 1 and (b) Pier 4 Columns of the Route 621 Bridge. Numbers in each square are the magnitude of the half-cell measurement but are reported as positive values instead of the measured negative value. The dashed line indicates approximate ground level location (VDOT Contracted I-64 Bridge Substructure Studies Project, Route 621, 2021).**

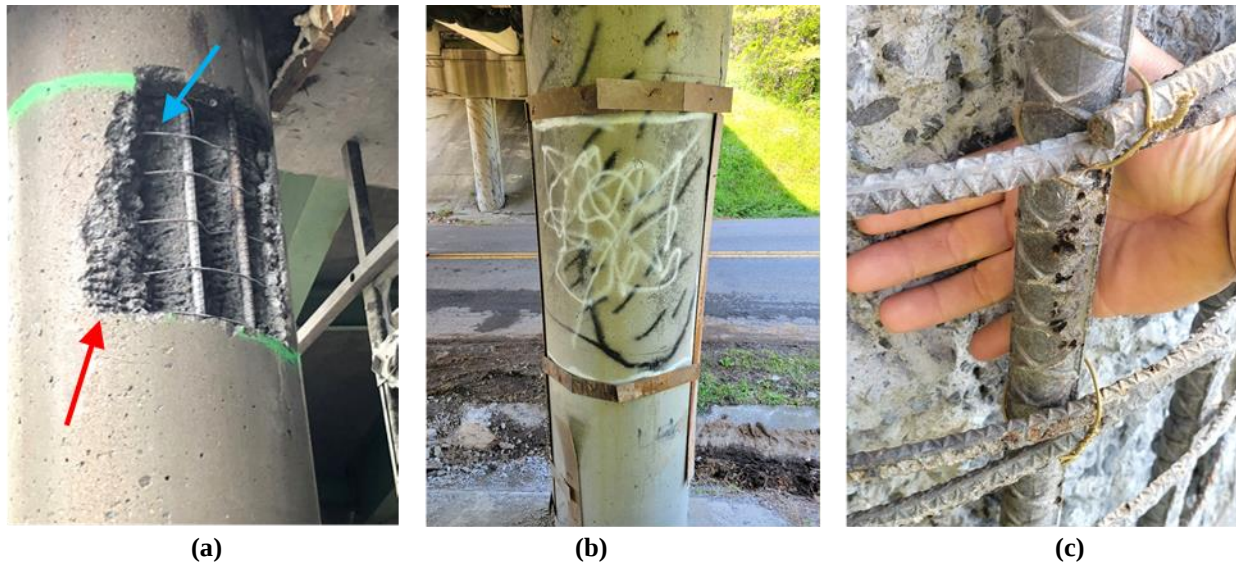
It was also difficult to get a smooth vertical cut at the edges of the Route 605 Bridge over I-64 (column along westbound lane shown in Figure 23). The water jet of the hydrodemolition unit provided direct water pressure, which left concrete behind the reinforcement and required manual removal. The high water pressure and the heterogeneous nature of concrete did prevented a sharp edge, leaving feather edges instead. The edge was saw cut about 3/4-inch to eliminate feather edging. The concrete along the perimeter was removed with hammers after the saw cut. In subsequent projects, improvements to vertical edge were achieved by placing straps around the perimeter (Figure 23). It is also possible that with new equipment and the lance, the operator can have smooth vertical faces to avoid feather edging without the straps. After completing hydrodemolition, the area must be pressure washed to remove the remaining cement slurry (Figure 24).

**Figure 23. Comparison of the I-64 Hydrodemolition and a Later Repair.** Photo (a) shows how equipment used on I-64 project did not provide a sharp edge (red arrow), and it was not able to remove concrete behind the reinforcing steel (blue arrow). More recent repair work in the Salem District (b) used straps along edges of the patch to help define a clean edge, and (c) the use of a lance allows for removal of concrete from behind the reinforcement because the lance can be tilted.

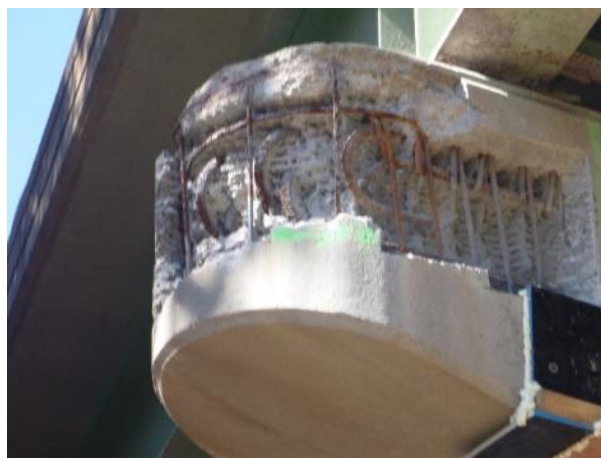
**Figure 24. Rout 605 Bridge over I-64 (Pier Cap along Eastbound Lane).** Concrete removed from the end of a pier cap using hydrodemolition. The area must be pressure washed to remove the cement slurry left after hydrodemolition.

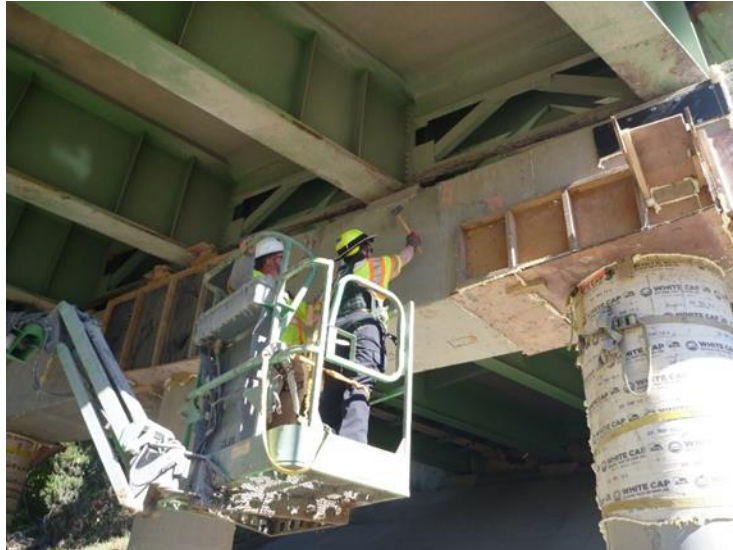
**Figure 25. Route 605 Bridge over I-64 (Columns and Pier Cap along Westbound Lane). After the removal of forms, the area was tapped with hammer to determine if the repairs were sound.**

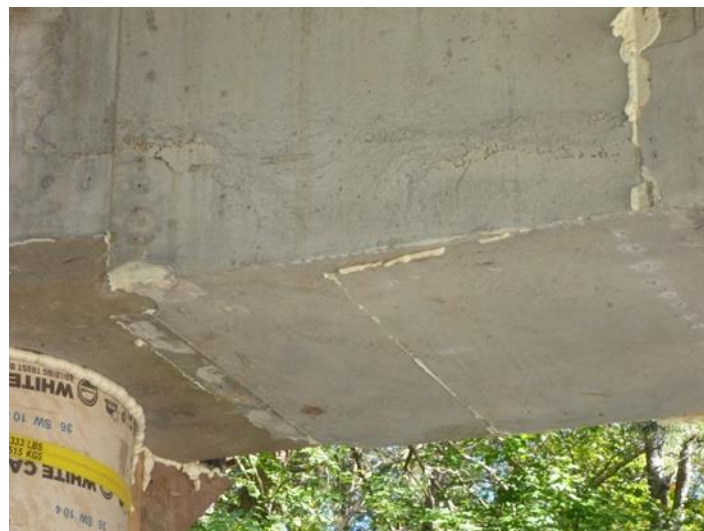
**Figure 26. Route 605 Bridge over I-64 (Column and Pier Cap along Westbound Lane). Although most of the self-consolidating concrete had a smooth surface, some small surface blemishes were evident.**

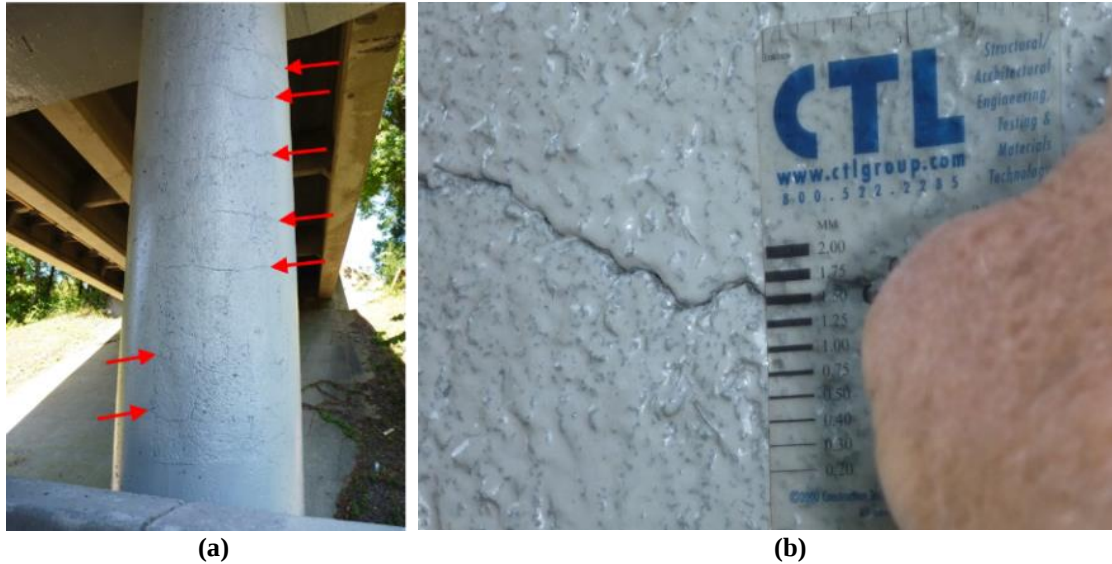
The first control bridge, Route 621 over I-64, was repaired using dry process shotcrete (Figure 30). An epoxy coating was applied to the repaired columns and pier caps for protection from the environment and elements. The column surface is rough, and it exhibits cracks which were 1 to 2 mm wide and are highlighted with red arrows. Separation along the edges of the repair area indicated excessive shrinkage. In the areas receiving shotcrete, a prepackaged material was used.

**Figure 30. Route 621 Bridge over I-64 (Column along Eastbound Lane). The red arrows (a) indicate cracks in the repair and (b) shows a closeup of a crack being measured.**

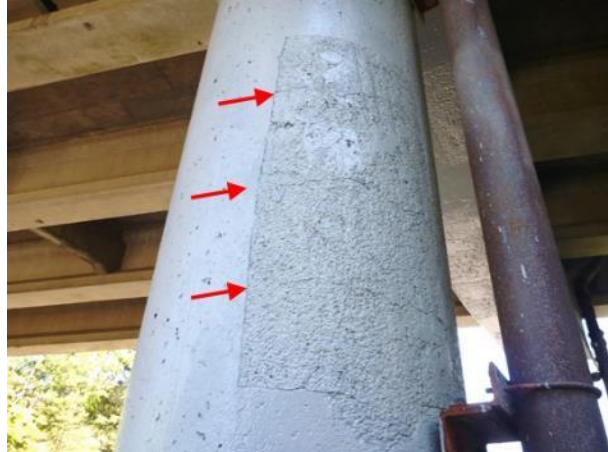
The rough surface and cracks (red arrows) are evident in the dry process shotcrete repair area of the Route 622 Bridge over I-64 (Figure 31). Areas repaired with shotcrete had rough surfaces and cracks. These bridge elements were coated with epoxy for additional protection because it covers the cracks, but the level of penetration is unknown.

**Figure 31. Route 622 Bridge over I-64 (Column along Westbound Lane). Red arrows show cracks in shotcrete repair.**

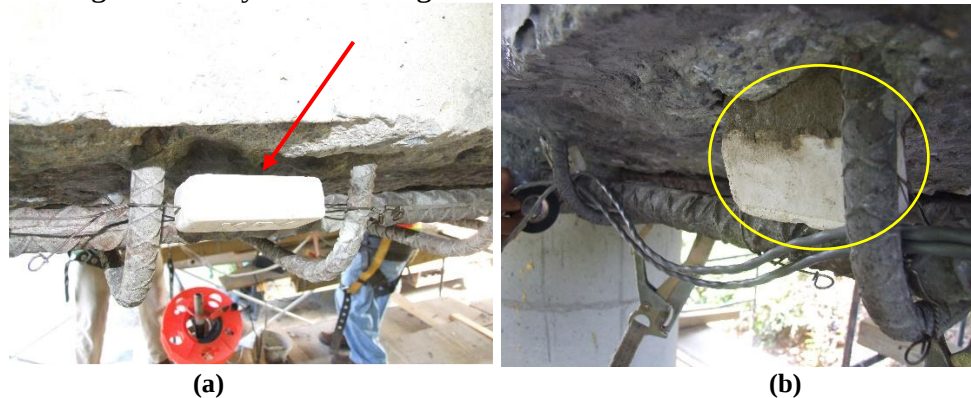
**Figure 32. (a) Anode Installed along the Perimeter of the Repair without Embedment Mortar between the Original Concrete and Anode as Indicated by the Arrow; (b) Anode Installed with Embedment Mortar (top of yellow circle) to Enhance Current Flow to the Original Concrete**
