# Field Evaluation of Reinforced Concrete Repairs Using Hydrodemolition, Galvanic Cathodic Protection, or Impressed Current Cathodic Protection

**Final Report VTRC 25-R22**

June 2025

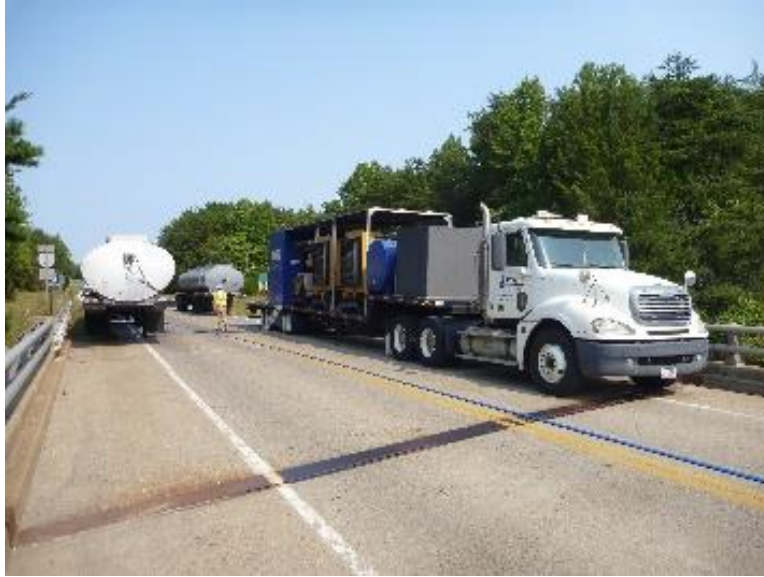
**Figure 19. Hydrodemolition Equipment is Parked on top of the Closed Bridge. Photo shows hydrodemolition truck and two tank trailers, one for fresh water and the other one for wastewater from the hydrodemolition.**

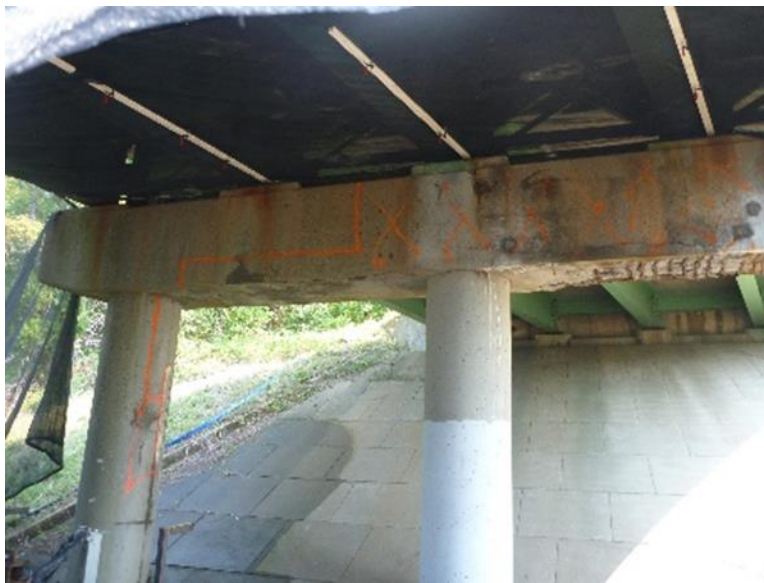
**Figure 20. Pier 1 Cap Where Hydrodemolition Will Be Performed**

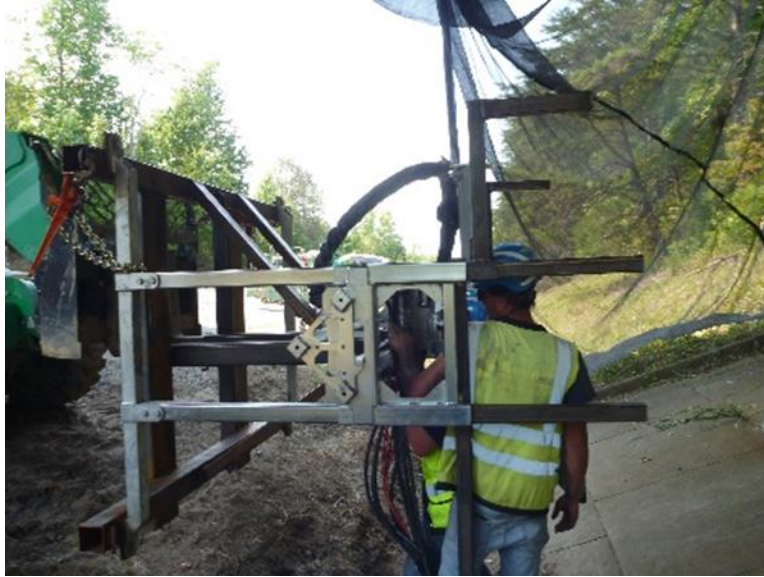
Prior to beginning the work, hydrodemolition equipment arrived on site and was calibrated (Figure 19). Hydrodemolition was performed on Route 605 structure Pier 1, span B (Figure 20), and Pier 3, span C. The water jet nozzle was lifted using a specially fabricated frame so that it was kept tight to the vertical concrete surface (Figure 21). Hydrodemolition was effective in removal of concrete in large flat areas. However, it was limited by how much concrete could be removed and the presence of deteriorated concrete in isolated areas. Concrete was removed at different depths because of the variability in the quality. With the available equipment, it was difficult to reach behind the reinforcement and the tight areas such as the underside of the cap, requiring additional chipping after hydrodemolition, as Figures 19–21 explain in more detail.

**Figure 21. Frame for Supporting Hydrodemolition Equipment**

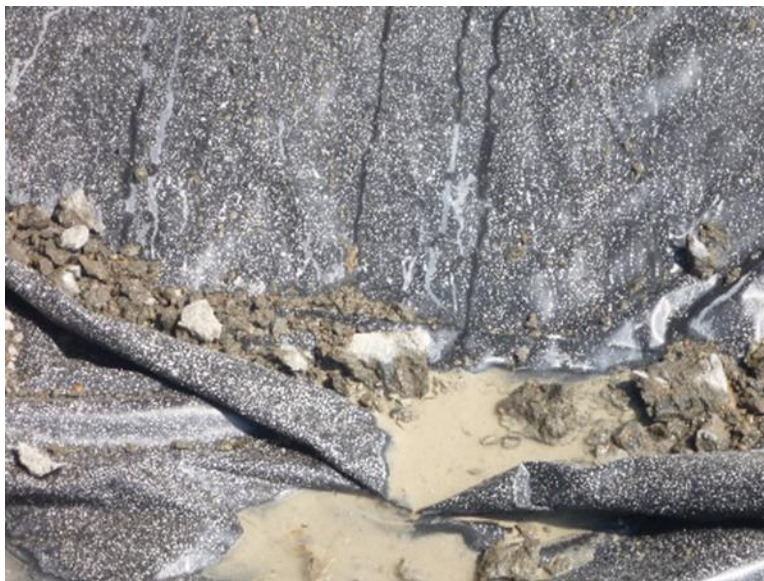
During hydrodemolition, three variables control the penetration depth: (1) pressure, (2) rate of travel, and (3) number of passes over a given area. The head in the frame moves vertically and then horizontally. For this work, pressure was kept constant at 34,000 psi, and rate of travel and number of passes were changed to control the depth of penetration. Initially, 7 inches were removed (3.5 inches from behind rebar) when the rate of travel was 20 ft/min with 2 passes, each pass was a vertical movement up and down. The time to perform this operation was approximately 1 minute. The number of passes and the rate of travel was calibrated to remove 1 inch behind the reinforcing bar. The concretes showed high variability necessitating trials in a 12 square-foot area to ensure 1 inch behind the bar is removed. The debris generated was captured and the water was separated from the solid waste (Figure 22). The wastewater was pumped into storage tanks (Figure 19) and the solid waste was discarded.

**Figure 22. Debris Generated after Using Hydrodemolition to Remove Concrete Is Captured. The wash water was pumped to the truck and the solid pieces discarded.**

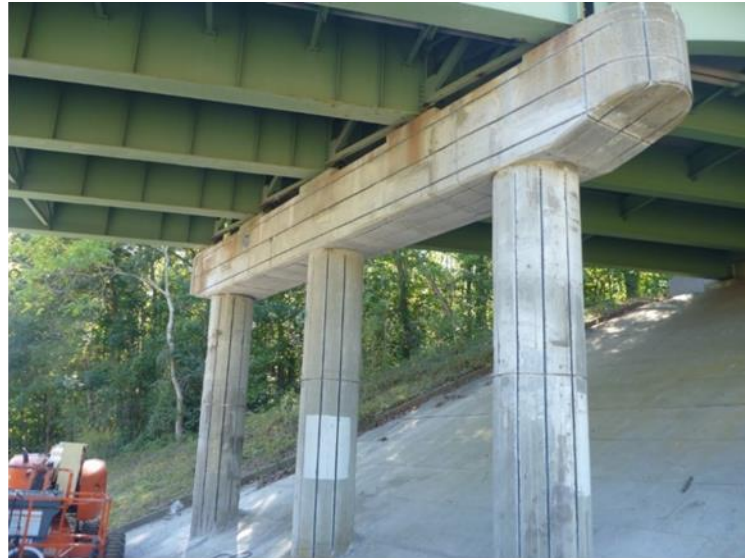
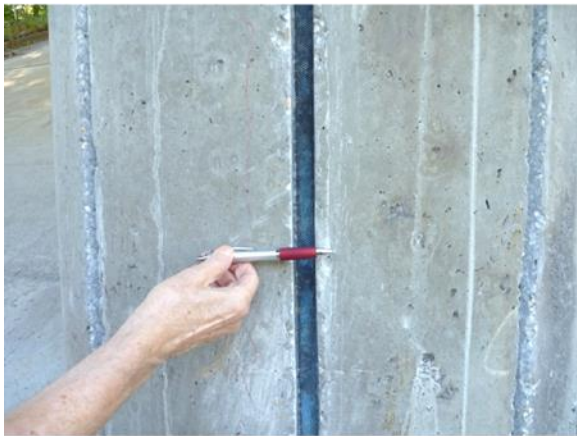
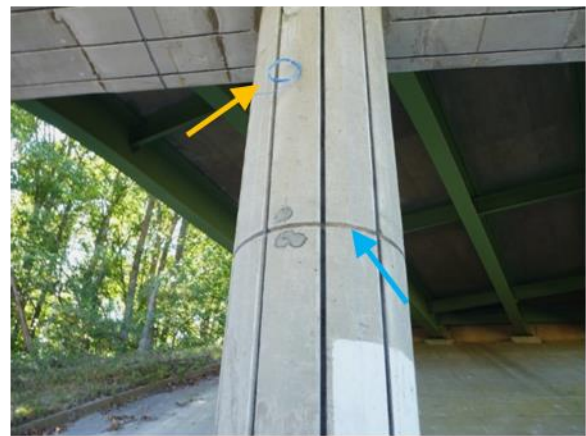
On the Route 629 Bridge, a solar-powered ICCP system was installed to provide corrosion mitigation current to the reinforced structure (Figure 27). The embedded mixed metal oxide titanium ribbon anodes, which are titanium strips covered with a mixed metal oxide coating, are placed in a manner that ensures that current is distributed across the element.

**Figure 27. Route 629 Bridge over I-64: (a) Overview of pier shows slots cut into the concrete; (b) the placement of titanium ribbon anodes (coated with a mixed metal oxide); and (c) current distributor band (blue arrow) connecting the ribbon anodes and a blue wire (orange arrow) that is connected to a silver-silver chloride reference cell installed in the concrete.**

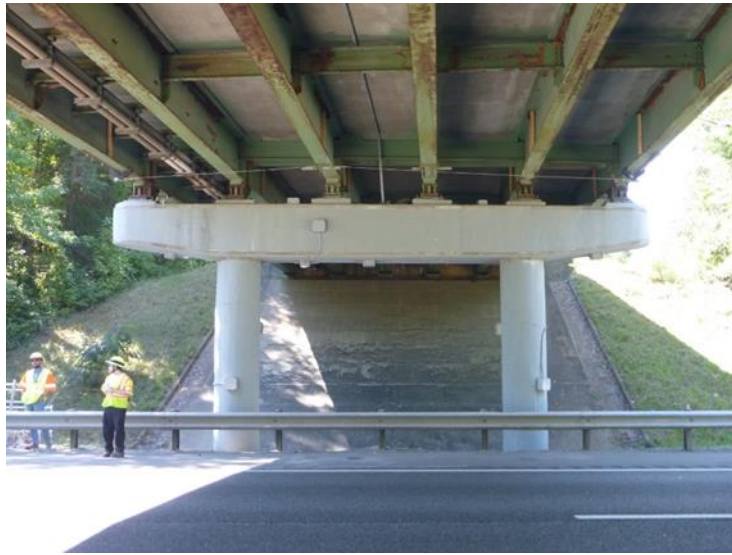
**Figure 28. Route 522 Bridge over I-64 that Had a Thermally Sprayed Zinc Coating Applied to the Concrete. It will function as the anode as part of an impressed current cathodic protection system.**

Unfortunately, some of the piers on these structures are under a joint that could leak. A leaking joint was observed on the Route 522 Bridge above Pier 4 after the ICCP system had been installed. This leak damaged a portion of the zinc on the pier cap before the leaking joint was repaired.

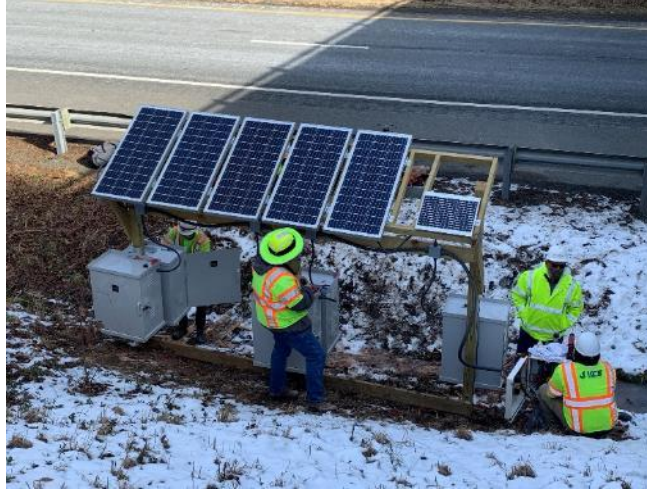
Each GCP and ICCP system is powered using solar panels (Figure 29). The five larger panels supply enough energy to provide CP current and charge the batteries, so that the system can mitigate corrosion day and night. The smaller solar panel provides power to the RMU and charges the battery for data to be collected and periodically transmitted.

**Figure 29. The Five Larger Solar Panels Supply Electricity for the Cathodic Protection System and the Smaller Solar Panel Powers the Remote Monitoring Unit**

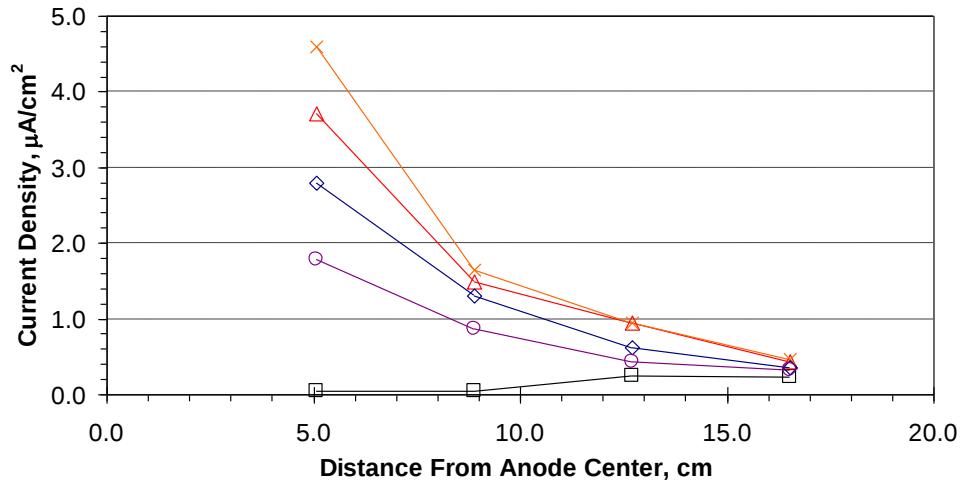
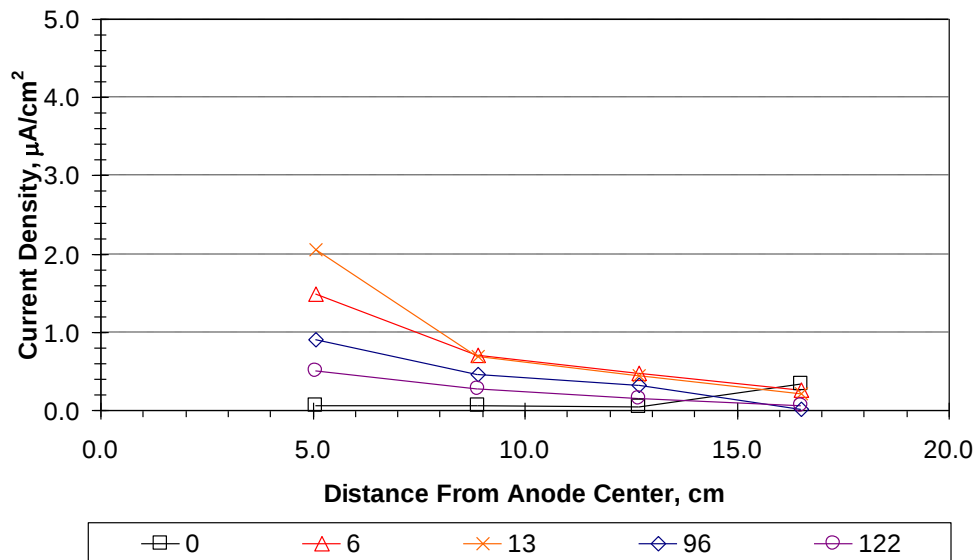
The three substructures were repaired with and without anodes to determine the life expectancy of each. The anodes used were provided by three different companies, so the anodes had distinct differences that were reported to improve efficiency. In some areas, anodes were placed with an embedment mortar to facilitate current flow to prevent corrosion of the reinforcement in the unrepaired areas. The nondestructive testing showed that anodes with or without embedment mortar had minimal effect on the corrosion protection. The unrepaired areas next to the patches started showing distress that would inevitably need repairs. Controlled laboratory studies have also indicated that the influence of the anodes on the reinforced concrete element and the benefit of using them are sensitive to both exposure time and concrete resistivity, which directly influence the projected anode life. Work by Dugarte and Sagüés (2014) concluded that “... throwing distance in likely application scenarios may seriously degrade within a few years of operation.” Similar behavior has also been observed in the VDOT elements repaired with these types of anodes in the field. For example, the current flow through the different steel bars first increases but then decreases with time (Figure 33), with most of the current going to the steel in closest proximity to the anode.

**Figure 33. VTRC 05-R25 Current Density Measurements from Sacrificial Anode Sensors Placed in (a) Pier 1 and (b) Pier 12. The numbers in the legend indicate the number of days that have passed since activating the anode.**

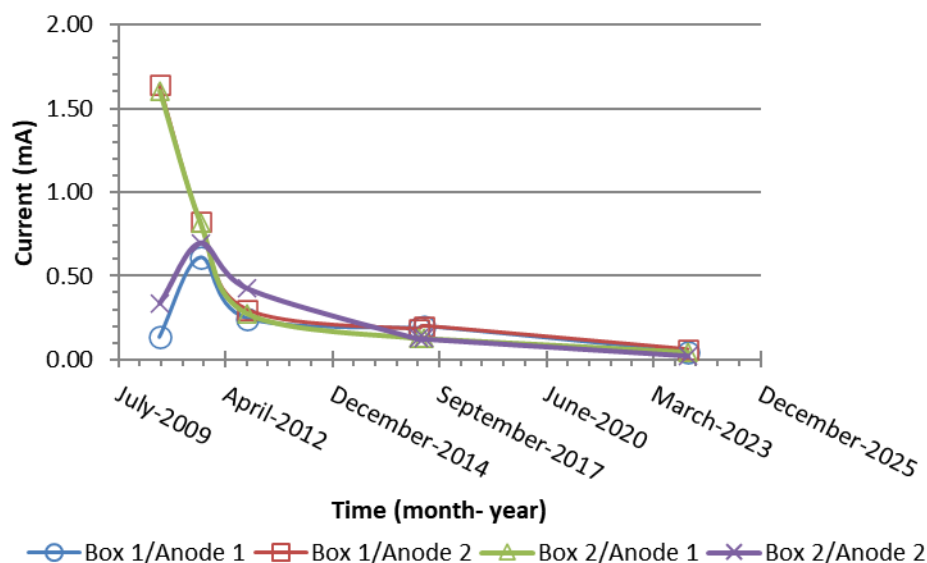
**Figure 34. Measured Current Values on Route 712 Bridge**

Thus, the technical assistance report concluded from field measurements of the current over time that most of the current flow occurs within 3 years of concrete placement. Field measurements also demonstrated that the distance the anode current extends from the center of the anode indicates that most of the current flows to the closest reinforcing steel bar. Both findings were not surprising because VDOT intentionally uses high resistivity concrete repair materials. The use of high resistivity concrete repair materials in patch repairs, with or without embedment mortar, limits the effectiveness of the DGP anodes. Therefore, the nearby unrepaired areas demonstrate the halo effect and show signs of corrosion-related distress within a few years of completion of the repair. Therefore, for long-term protection of the steel reinforcement, mitigating corrosion required either (1) total removal of the deteriorated concrete to below the reinforcement and replacement with a quality low-permeability concrete that naturally exhibits high resistivity, but without the DGP anodes, or (2) leave some of the deteriorated concrete in place and install an ICCP or GCP system to mitigate future corrosion on the whole element.
